NASA Contractor Report 166012

FULL-SCALE TESTING, PRODUCTION, AND COST ANALYSIS DATA FOR THE ADVANCED COMPOSITE STABILIZER FOR BOEING 737 AIRCRAFT

VOLUME II—FINAL REPORT

December 1982

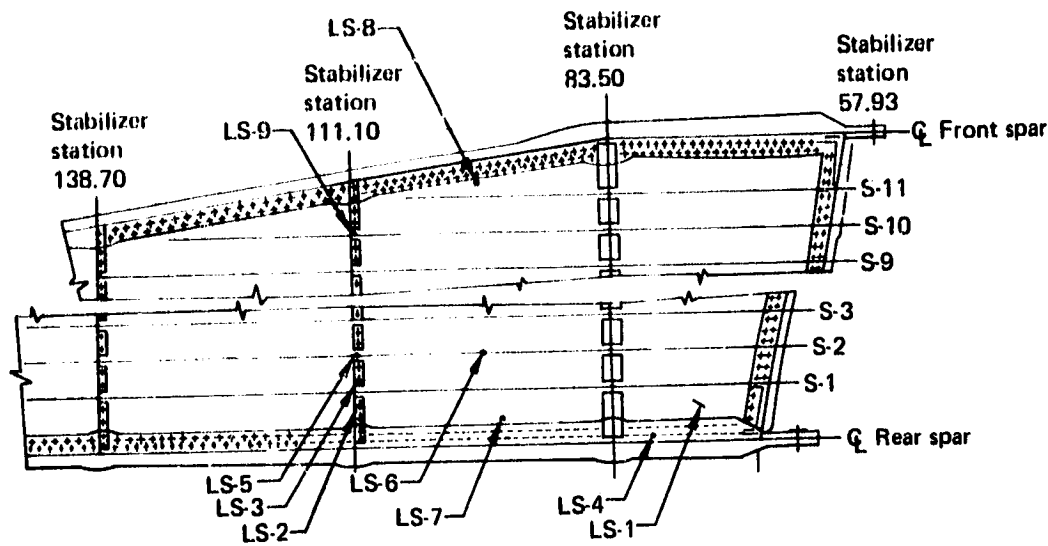
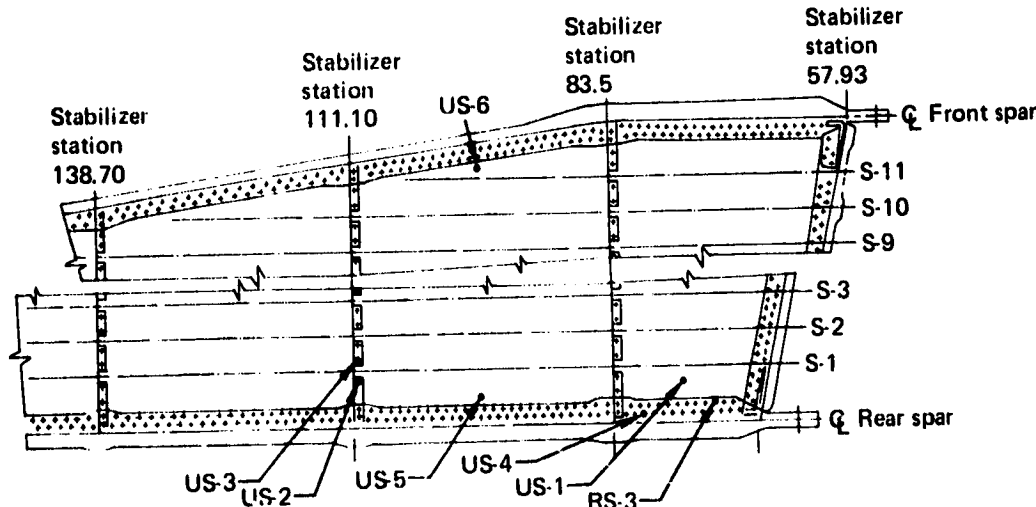
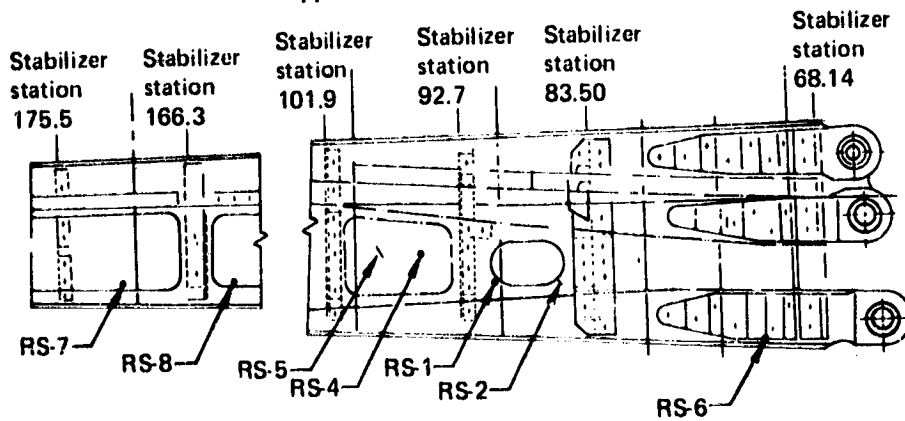
Figure 10. Induced Damage Locations

With simulated service and/or maintenance damage inflicted in selected areas, a total of 80 000 spectrum load flights representing one lifetime of aircraft service were applied to the stabilizer. The damage is defined in Table 1 and shown in Figure 10. Visual, ultrasonic, and X-ray inspections were performed at routine intervals, and strain and deflection data were recorded at specific flight intervals.

Impact damage. Detectable by visual inspection.

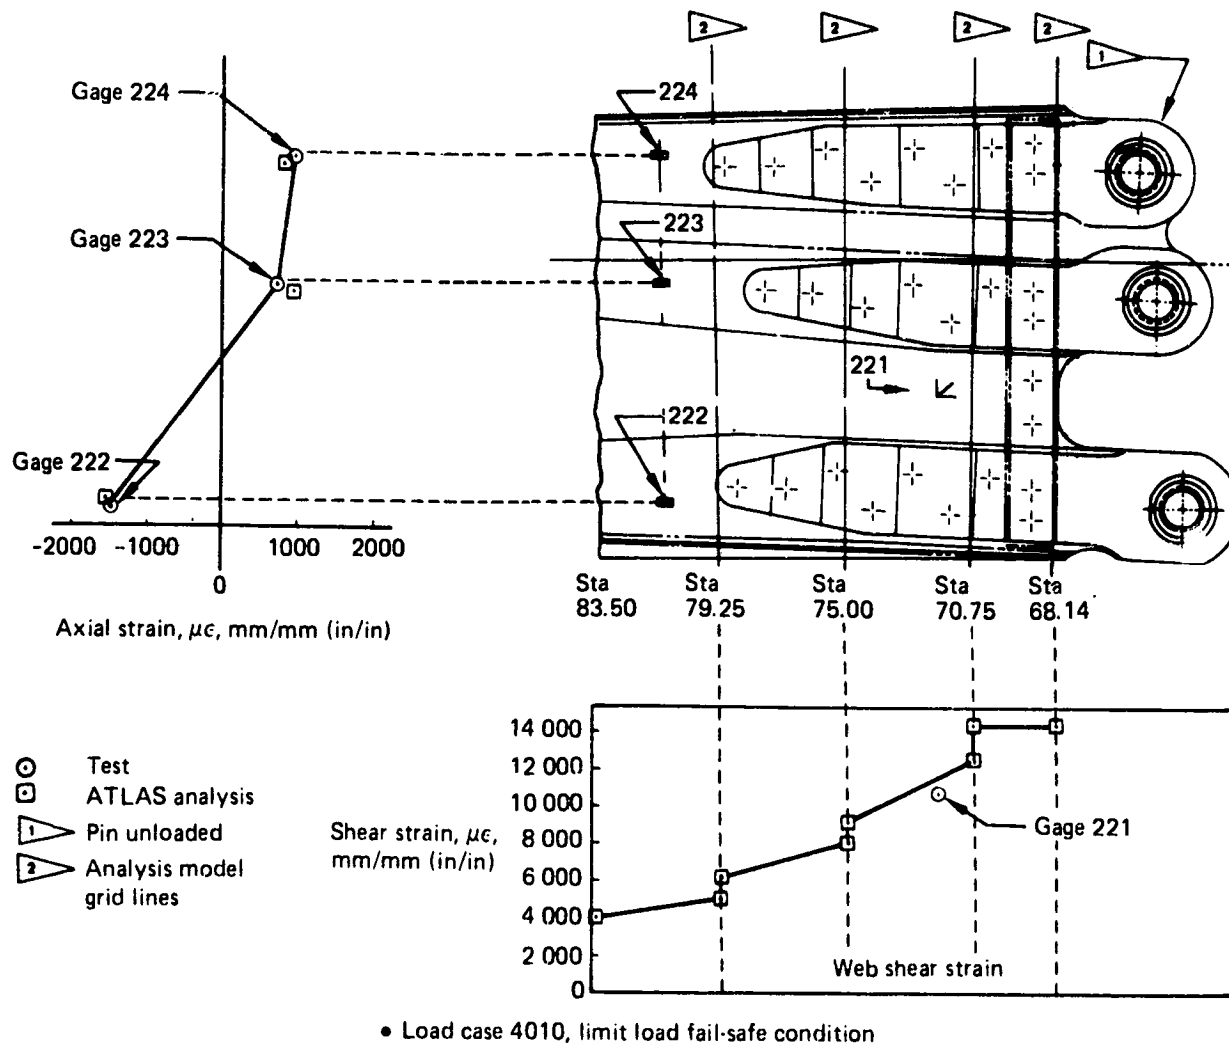
Figure 30. Finite Element and Strain Gage Comparison

The ATLAS finite element model analysis results for the spar web shear are compared with the linear extrapolated strain gage data in Figure 30. This comparison shows close agreement. Figure 30 also shows close agreement between the axial strains in the spar chords.

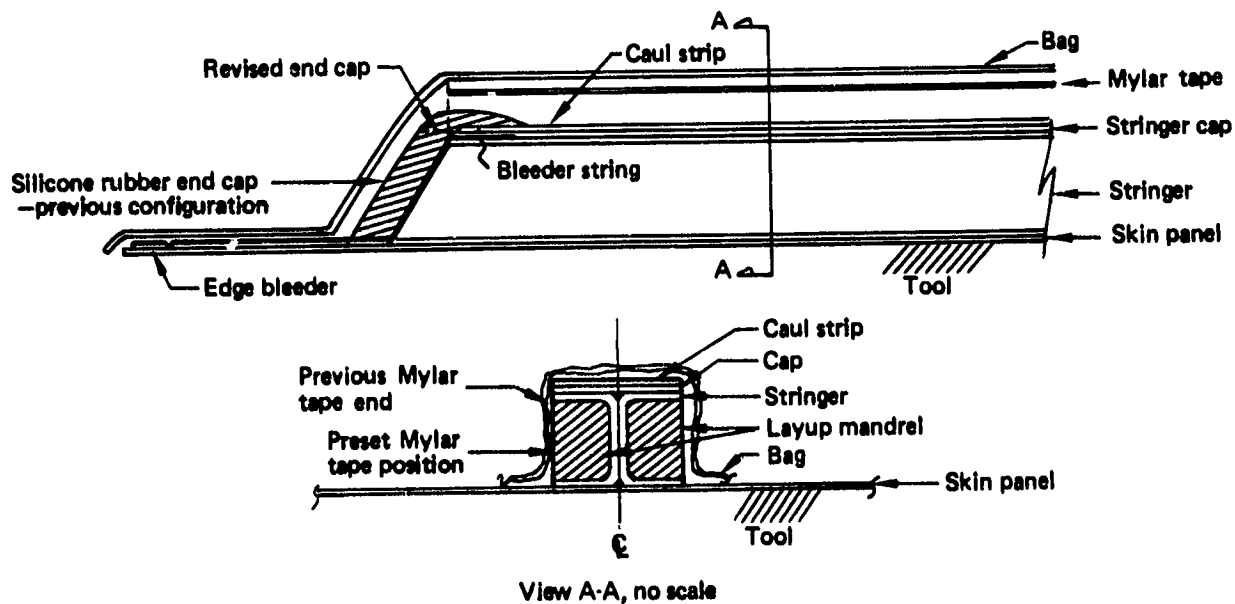
Figure 59. Stabilizer Typical Skin Panel/Stringer Layup

Delamination Shipset 1, Right-Hand Upper Skin Panel—Component fabrication for shipset 1 was completed on schedule except for the right-hand upper skin panel. Completion of this panel was delayed by an unexpected problem caused by delamination of some of the stringer caps after the cure cycle. This production article exhibited delamination in five stringers (fig. 58).

Two sets of test panels were constructed to determine the cause of the problem. The first panel was five stringers wide and 152.4 cm (5 ft) long. Suspected factors tested were material age, bagging techniques, caul-strip buckling, and bond-line contamination. This panel showed no delamination. The age of the material was ruled out as a contributing factor, but it was determined that a full-length panel test was required to fully assess other probable causes. The second panel was six stringers wide, each with a different layup and bagging technique for capping the stringer ends, tying down the aluminum caul strips, and for resin bleeding.

The full-length test panel showed no delamination and established the need for revisions in present layup and bagging techniques to ensure that the condition would not recur. As a result, the full-size production panel was remade with the following changes (fig. 59):

- Caul strips were shortened and refinished with Teflon to provide less friction and prevent buckling.
- Mylar tape used to hold caul strips in place was extended to tie into the stringer mandrels.
- String was added at the ends of stringers to provide a bleeder path to the edge bleeder.

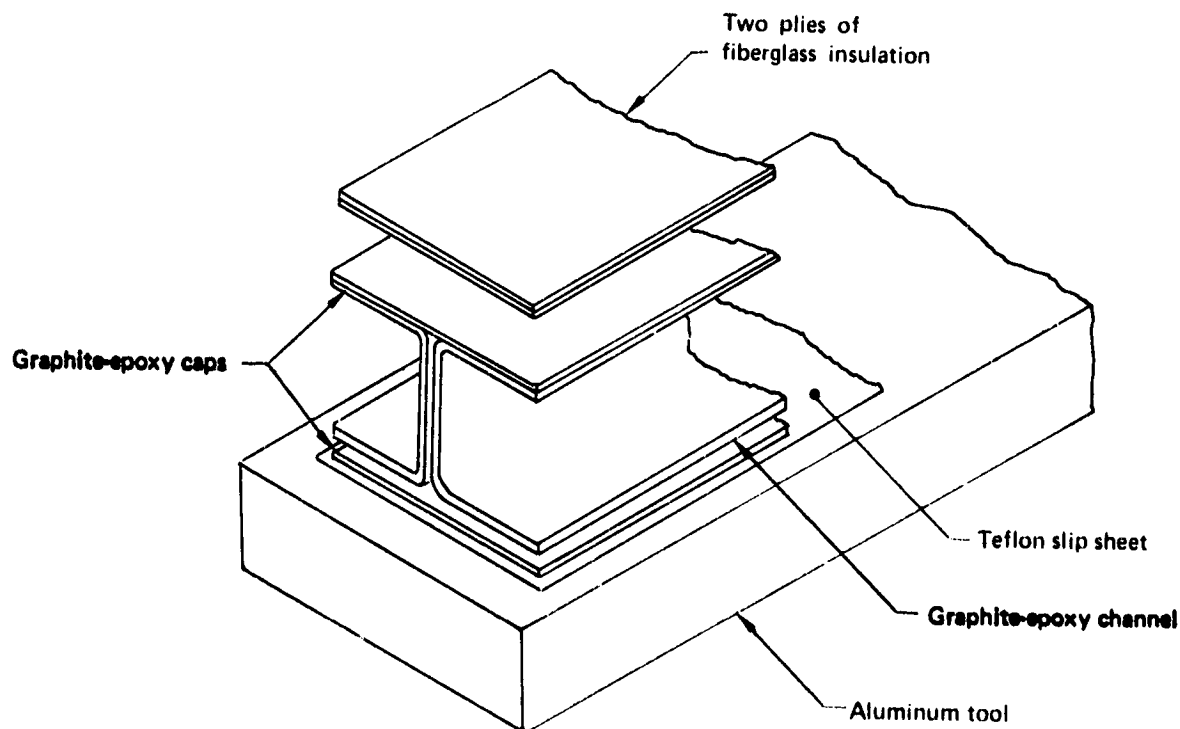
Figure 60. Spar Bonding

Evaluations of the fabrication processes used during production of the left-hand units and developmental test programs showed that there were three primary reasons for warpage: temperature differential between the tool-side spar cap and the upper spar cap, interface friction between the tool and the part, and cool-down rate. To correct these conditions, processing changes were made:

Note: Use of fiberglass insulation and Teflon slip sheet to reduce warpage

- **Temperature differential.** Two plies of style 1597 fiberglass were placed over the upper spar cap as an insulation blanket to balance the temperature between the upper and lower cap during autoclave cure (fig. 60).

- **Spar/tool interface friction.** A Teflon slip sheet was applied between the tool surface and the part to allow expansion and contraction of the tool without inducing stress buildup in the part (fig. 60).
- **Cool-down rate.** The rate was controlled to a maximum of $1^{\circ}\text{C}/\text{min}$ ($2^{\circ}\text{F}/\text{min}$) rather than to the allowable $3^{\circ}\text{C}/\text{min}$ ($5^{\circ}\text{F}/\text{min}$).
